Incident Title:	Fall from height during well intervention activity
Outcome:	Near miss
Location:	Permian Basin

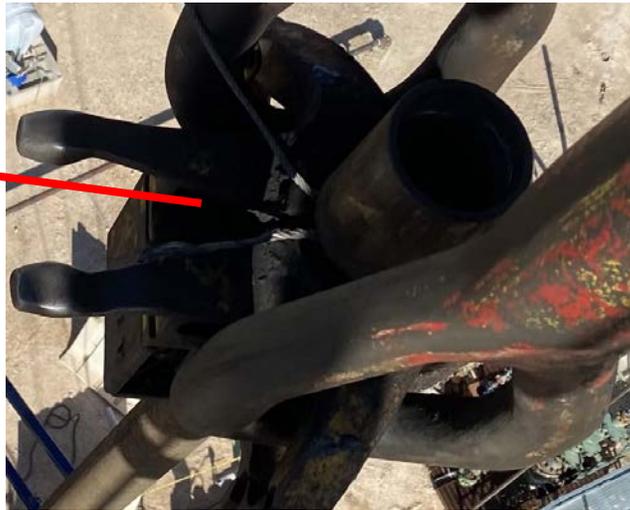
Note the SRL line caught between the tubing collar and elevators

- Do not allow Derrickman to wrap SRL line around anything, doing so can:
 - Create slack in the lifeline which can be caught by moving parts in the derrick, and/or
 - Prevent the SRL from functioning properly in the event of a fall.
- Contractor companies implement a method of verification for monitoring compliance and taking corrective actions for non-compliance.

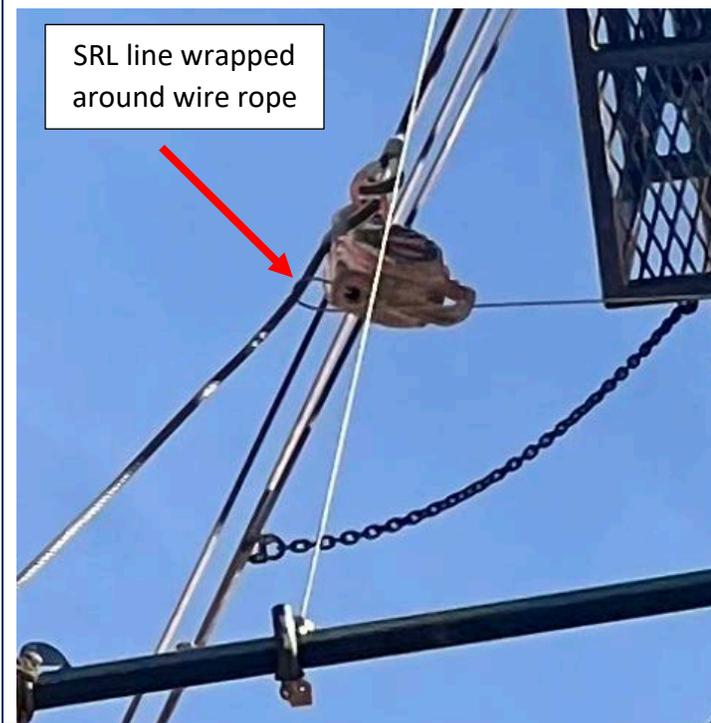
Tension forces applied to the safety harness deployed the impact indicators as designed (like impact loading in the event of a fall).
