Incident Title:	Fall from height during well intervention activity
Outcome:	Near miss
Location:	Permian Basin

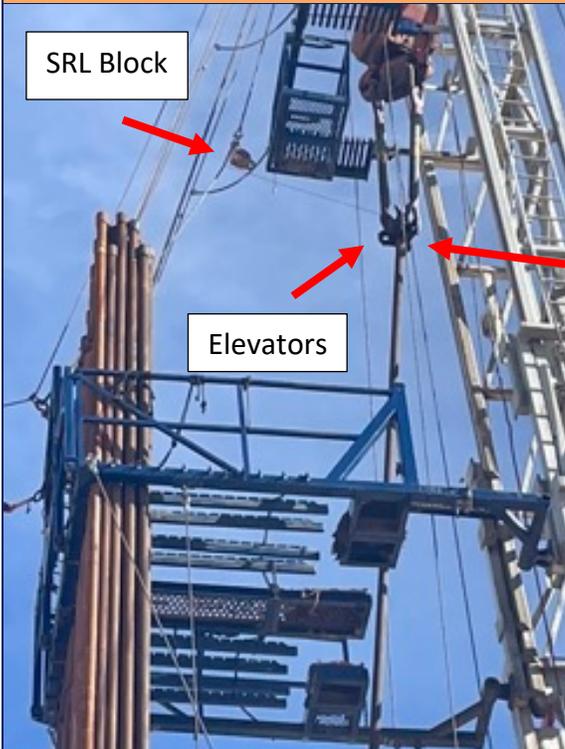
- While tripping tubing in the hole, the derrickman's self-retracting lifeline (SRL) became wrapped around the tubing stand being latched in the elevators.
- As a result, the derrickman was lifted approximately 7' off the tubing board before the SRL line broke and tore his safety harness.
- The derrickman, still fastened by the positioning lanyard (belly rope), fell to the tubing board.
- Risk controls in place: IOGP life saving rule Working at Heights and company verifications

Note the SRL line caught between the tubing collar and elevators

- Do not allow Derrickman to wrap SRL line around anything, doing so can:
 - Create slack in the lifeline which can be caught by moving parts in the derrick, and/or
 - Prevent the SRL from functioning properly in the event of a fall.
- Contractor companies implement a method of verification for monitoring compliance and taking corrective actions for non-compliance.

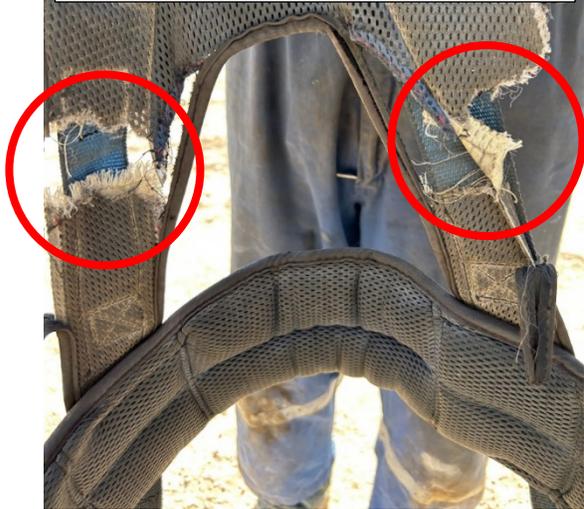
Tension forces applied to the safety harness deployed the impact indicators as designed (like impact loading in the event of a fall).
